Coal Combustion Waste Impoundment

Round 5 - Dam Assessment Report

La Cygne Generating Station (Site 010)

Bottom Ash Settling, Upper and Lower AQC Ponds

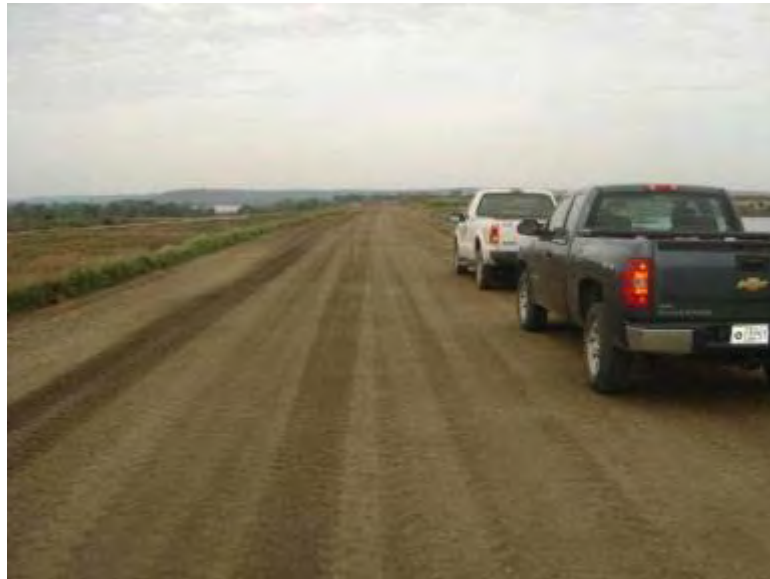
The crest of the dike had no signs of depressions, tension cracks, or other indications of settlement or shear failure, and appeared to be in satisfactory conditions. Figure 5.2.1-1 shows the conditions of the crest of southern dike of the Upper AQC Pond.

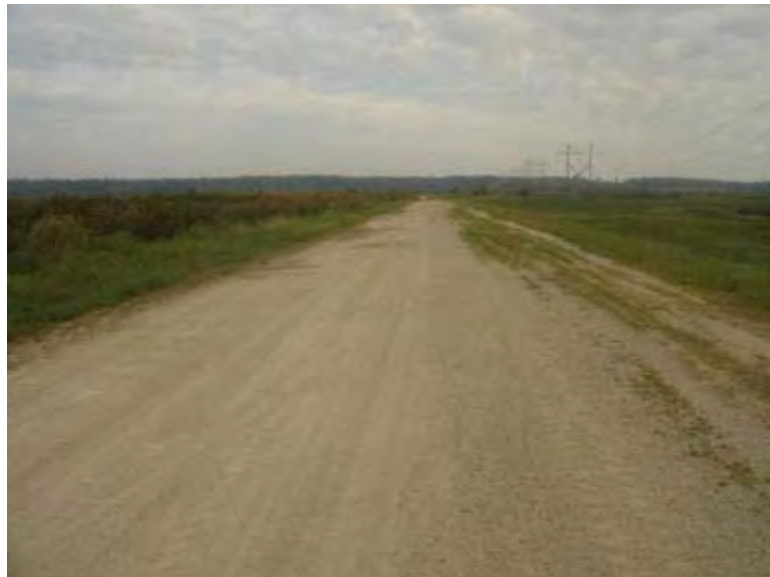
Figure 5.2.1-2 shows the conditions of the crest of eastern dike of the Upper AQC Pond.

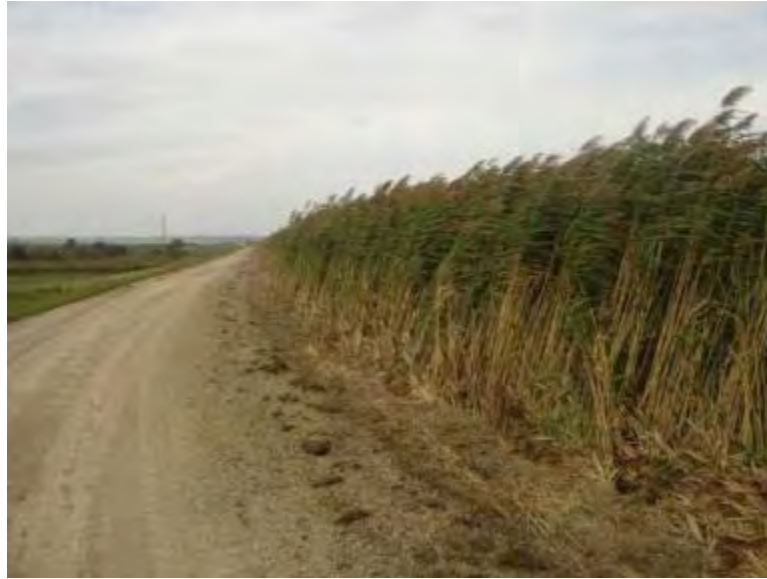
Figure 5.2.1-3 shows the conditions of the crest of northern dike of the Upper AQC Pond.

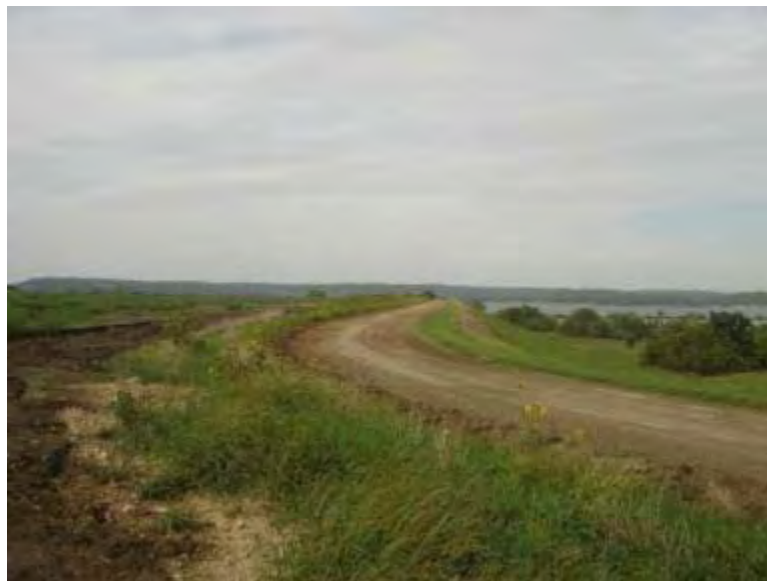
Figure 5.2.1-4 shows the conditions of the crest of western dike of the Upper AQC Pond.

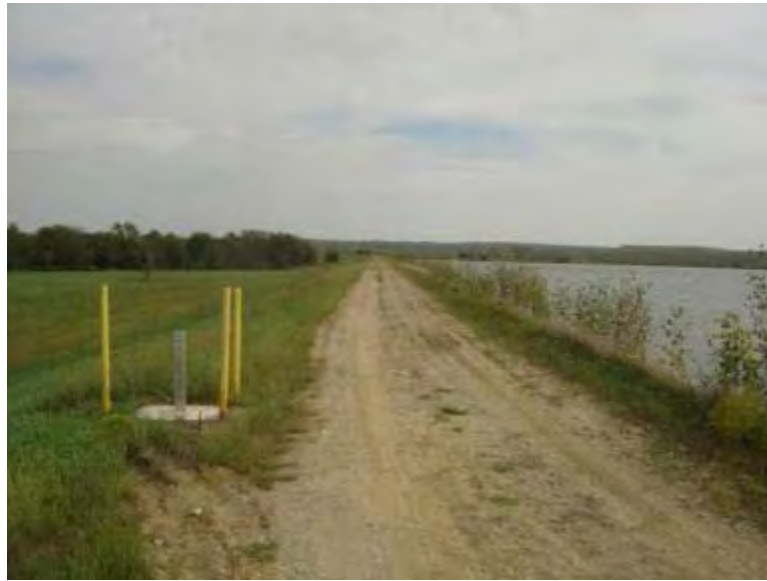
The crest of the dike had no signs of depressions, tension cracks, or other indications of settlement or shear failure, and appeared to be in satisfactory conditions. Figure 5.2.1-5 shows the conditions of the crest of southern dike of the Upper AQC Pond.

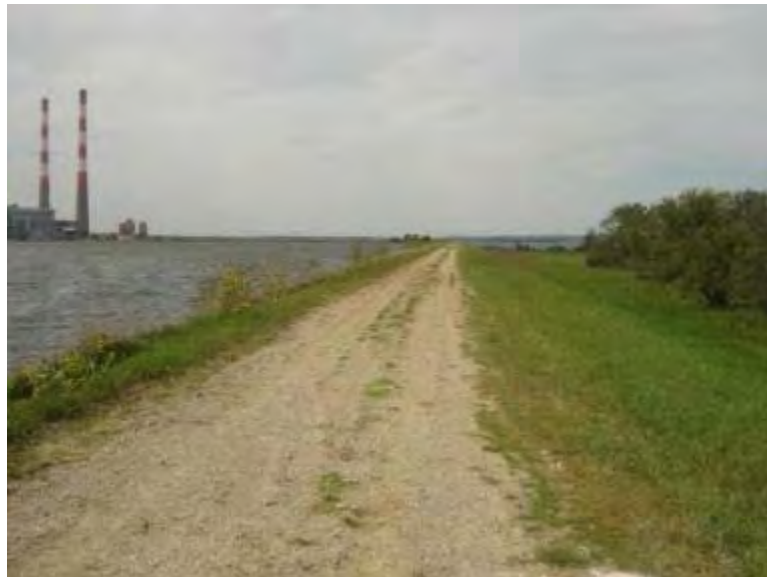
Figure 5.2.1-6 shows the conditions of the crest of western dike of the Upper AQC Pond.

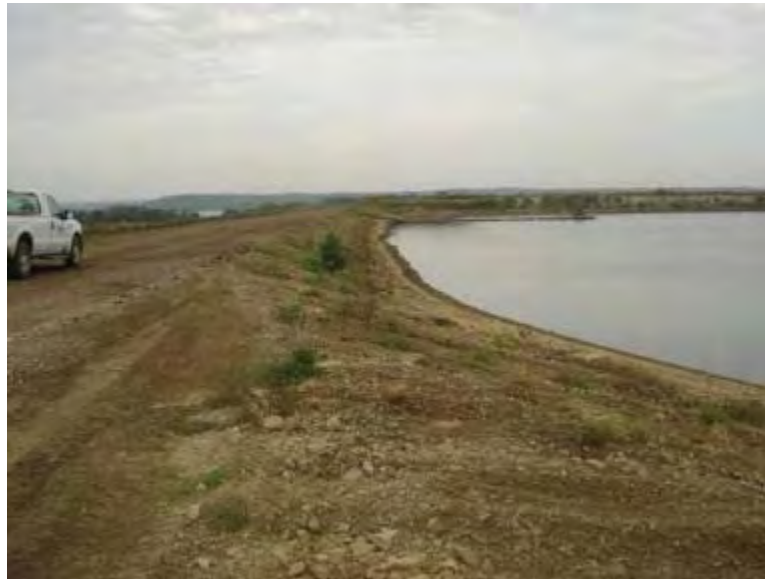
The inside slope of the south dike had no observed scarps, sloughs, bulging, cracks, or depressions or other indications of slope instability or signs of erosion. Figure 5.2.2-1 shows the general condition of the inside slope of the south dike.

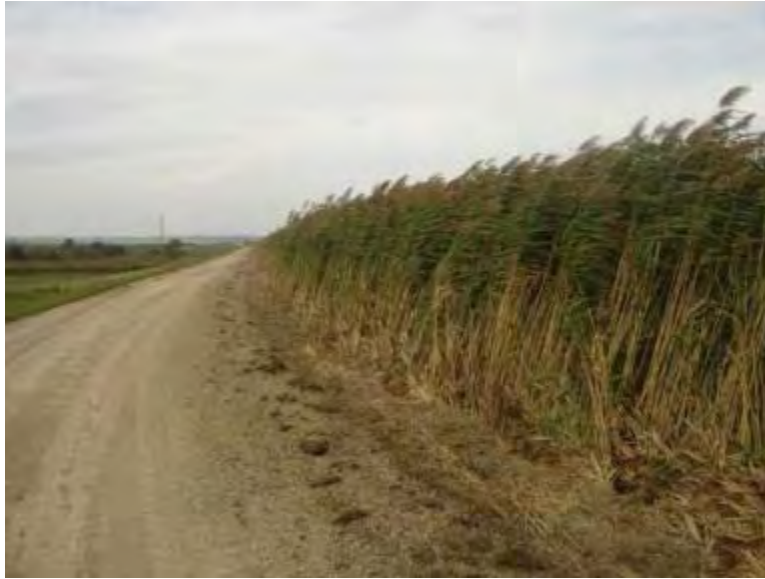
The inside slope of the eastern and northern dikes had no observed scarps, sloughs, bulging, cracks, or depressions or other indications of slope instability or signs of erosion. However, a large majority of the slope was obstructed due to heavy vegetative cover. The vegetative cover was intentionally placed by KCP&L personnel to increase the evapotranspiration rate within the pond.

Figure 5.2.2-2 shows the general condition of the inside slope of the east and north dikes.

It is recommended that Kansas City Power & Light remove the brushy vegetation from the interior slope of the Upper AQC Pond. This brush needs to be removed from the levees and within 25 feet from the toe of the levee slope. This should be done before trees can develop.

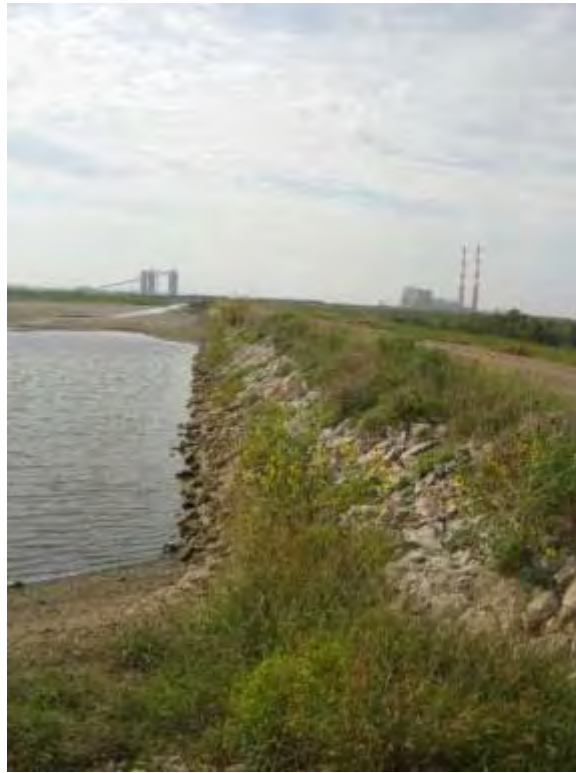
The inside slope of the west dike had no observed scarps, sloughs, bulging, cracks, or depressions or other indications of slope instability or signs of erosion.

Figure 5.2.2-3 shows the general condition of the inside slope of the west dike.

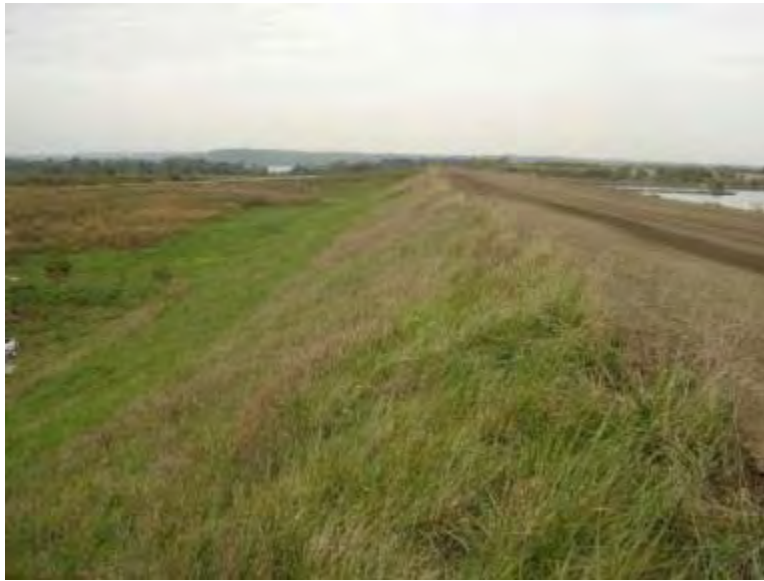
Figure 5.2.3-1

The down-gradient slope of the Upper AQC Pond southern dike is vegetated with grass. No major scarps sloughs, bulging, cracks, depressions, or other indications of slope instability or signs of seepage were observed.

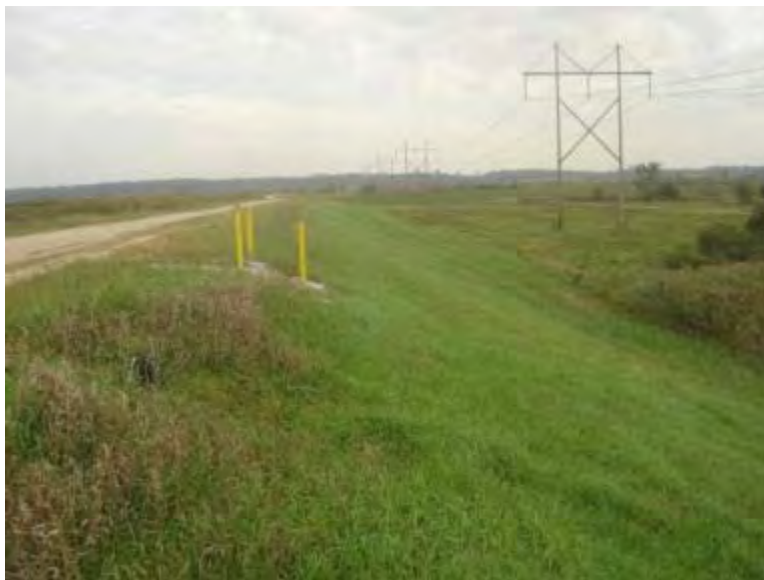
The down-gradient slope of the Upper AQC Pond eastern dike is vegetated with grass. No major scarps sloughs, bulging, cracks, depressions, or other indications of slope instability or signs of seepage were observed.

Figure 5.2.3-2 shows a representative section of the embankment.

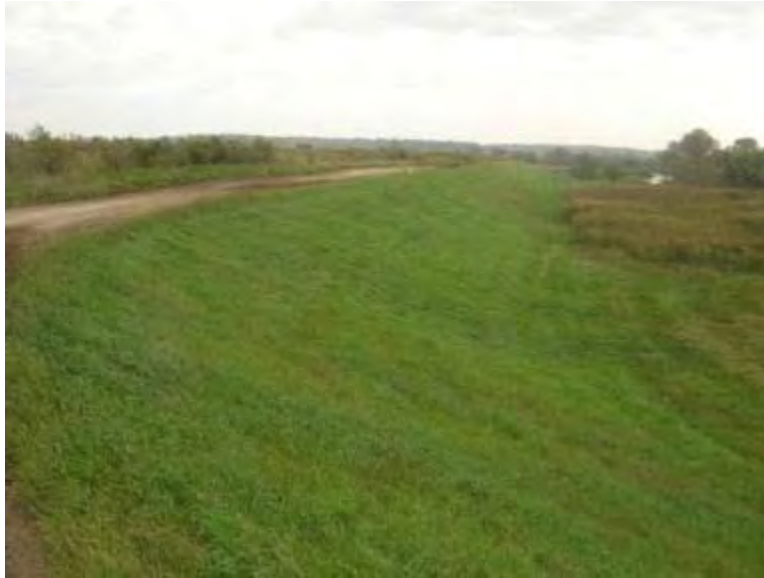
The down-gradient slope of the Upper AQC Pond northern dike is vegetated with grass. No major scarps sloughs, bulging, cracks, depressions, or other indications of slope instability or signs of seepage were observed. Figure 5.2.3-3 shows a representative section of the embankment.

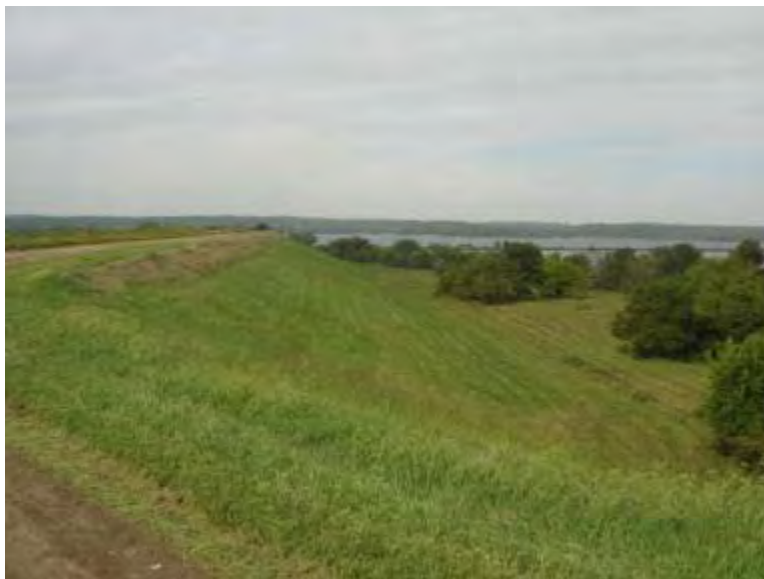
The down-gradient slope of the Upper AQC Pond western dike is vegetated with grass. No major scarps sloughs, bulging, cracks, depressions, or other indications of slope instability or signs of seepage were observed. Figure 5.2.3-4 shows a representative section of the embankment.

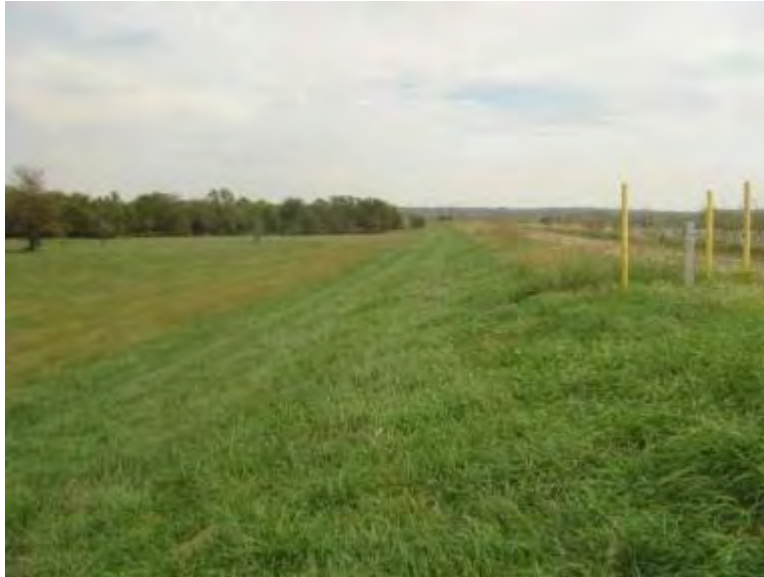
The down-gradient slope of the Lower AQC Pond southern dike is vegetated with grass. No major scarps sloughs, bulging, cracks, depressions, or other indications of slope instability or signs of seepage were observed. Figure 5.2.3-5 shows a representative section of the embankment.

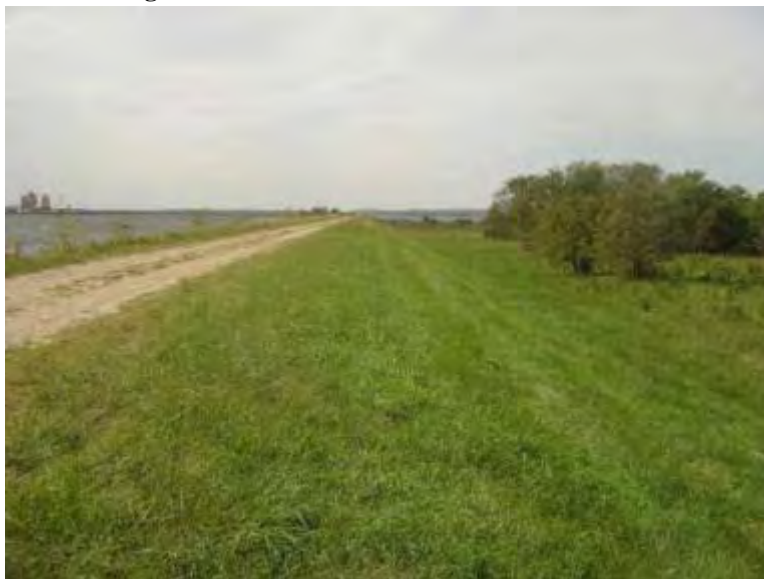
The down-gradient slope of the Lower AQC Pond western dike is vegetated with grass. No major scarps sloughs, bulging, cracks, depressions, or other indications of slope instability or signs of seepage were observed. Figure 5.2.3-6 shows a representative section of the embankment.

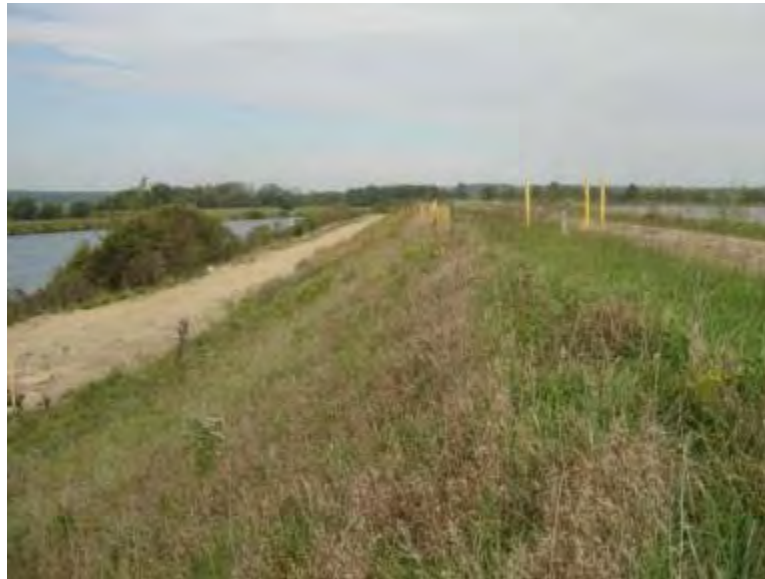
Figure 5.2.4-1

Neither erosion nor uncontrolled seepage was observed along groins or abutments. Groin slopes and abutments are protected with the same vegetative cover as the adjoining slopes. Figures 5.2.4-1 shows typical conditions observed at the northwestern abutment between the Upper and Lower AQC Ponds.

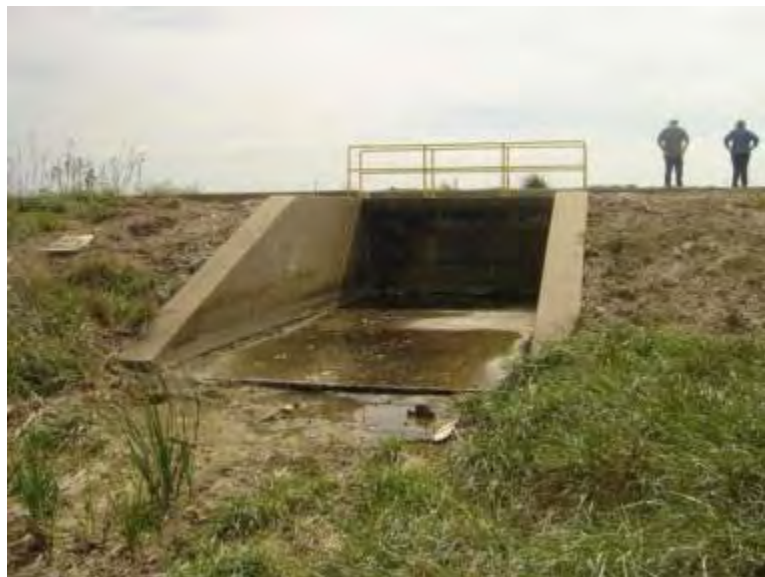
The Lower AQC Pond overflow structure is located at the northern quarter of the western embankment. The spillway consists of an 8'x15' box reinforced concrete structure. The overflow drains directly into the La Cygne Generating Station cooling water lake. The structure appears to not have been used in recent history. However, some seepage was observed coming out of the box. Figure 5.3.1-2 shows the primary spillway structure for the Upper AQC Pond.

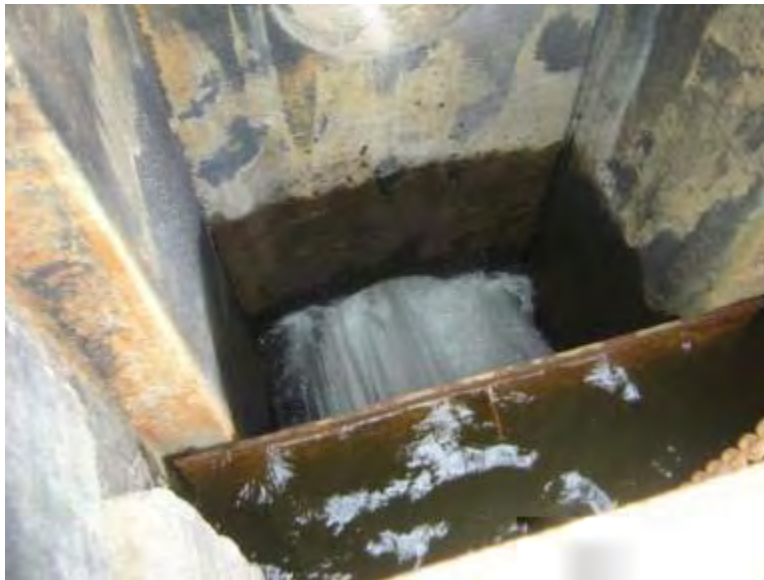
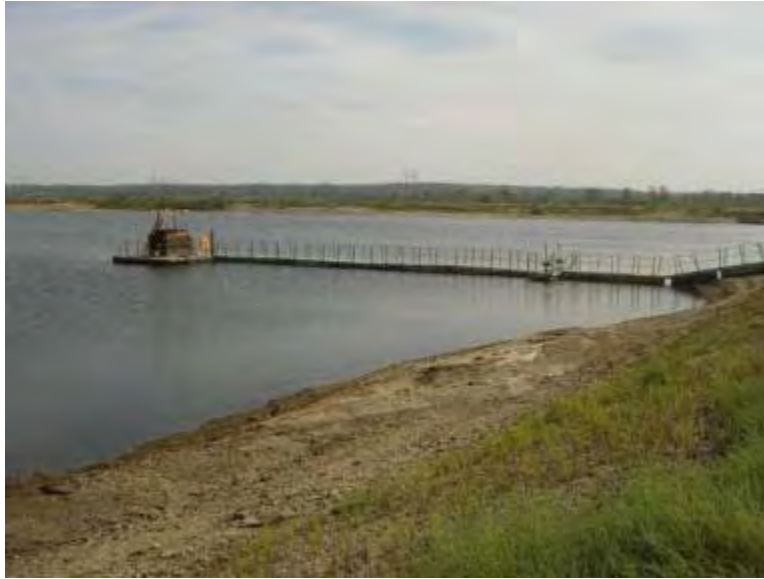
Figures 5.3.2-1 and 5.3.2-2 show the primary outlet structure for the Upper AQC Pond.
